BELZONA REPAIRS THE HYDRO PLANT INLET PIPE

Hydropower plant, Usk, WA

March 2014

Water inlet pipe of a hydro plant.

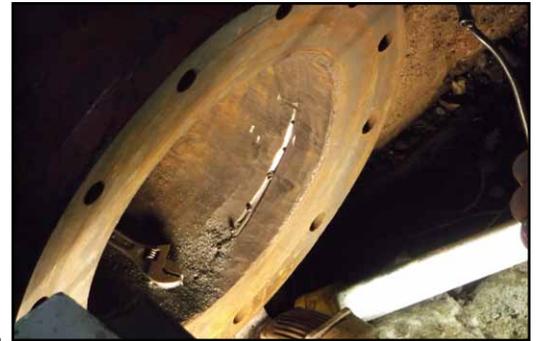
A nearby landslide had shifted the waterline inlet of the hydro project causing extreme pressure on the cast iron pipe near the inlet. This caused the pipe to begin splitting behind the flange due to misalignment.

1. Overview of "vee" out cracks and drilled holes with inserted screws
2. Sweating out with the rosebud torch
3. First layer of Belzona 1111 scrubbed in
4. Completed application

The surface was ground with a coarse grinding wheel to expose the full length of the crack. The crack was "vee'd" out and holes were drilled at each end all the way through, and 75% through every 1". The holes were then tapped and screws inserted and ground off flush to prevent movement in the crack. The area was sweated out with a rosebud torch, and a final surface preparation of grinding was done. Belzona 1111 was scrubbed into the surface and a thin layer applied before laying in a coated piece of Belzona 9341. The application was finished off with a final layer of Belzona 1111.
