BELZONA REPAIR TO MARINE ENGINE BLOCK

12 Cylinder Diesel engine from ship

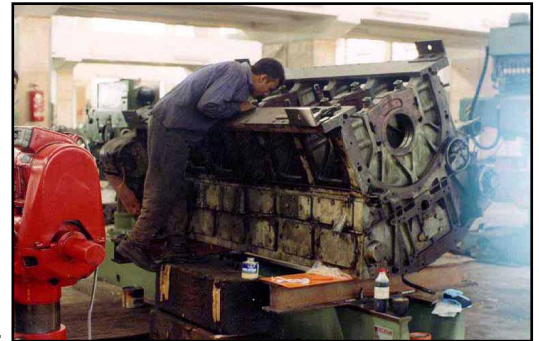
Crankshaft Bearing shells spun in housing causing wear in the housing necessitating rebuilding before new shell bearings installed.

1. Application underway to the engine crankcase
2. Belzona® 1111 applied to housing
3. Line boring of housings underway
