## BELZONA REPAIR ON 10,000 HP SULZER MARINE DIESEL ENGINE

Shipping company in Ontario, Canada

Six cylinder Sulzer Diesel Engine built in 1969.

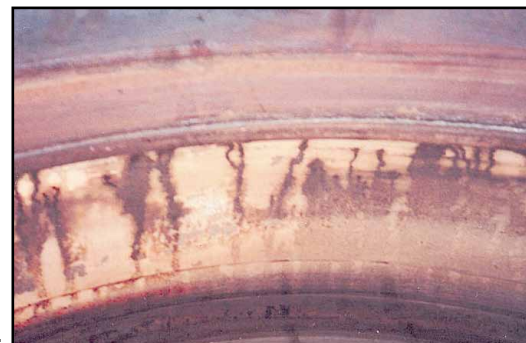
2.

Pitting corrosion on engine block caused o-ring seals to leak.

Each cylinder is 36" in diameter, each had three corroded lands about 4" wide. Customer felt conventional weld repairs would have been too risky, and that Belzona was the only viable alternative.
