BELZONA REBUILDS KILN SUPPORT ROLLER SHAFT

Chemical manufacturer (Chromium)

April 2005

Worn seal area on kiln support roller shaft.

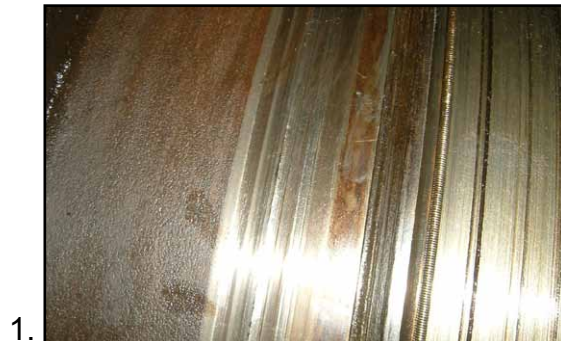
In service the shaft had become worn in the area where the lip seal ran. This allowed oil to leak past the seal resulting in the need for regular oil level checking and refilling as well as a serious slip hazard in the surrounding area.

1. Worn area of shaft
2. View of surface preparation
3. Completed repair
4. Close up of Belzona® 1131 repair
