BELZONA RESTORES THIS FAN PUMP TO LIKE NEW CONDITION

Pulp and paper mill in Georgia, U.S.A.

35,000 GPM Gould's Primary Fan Pump.

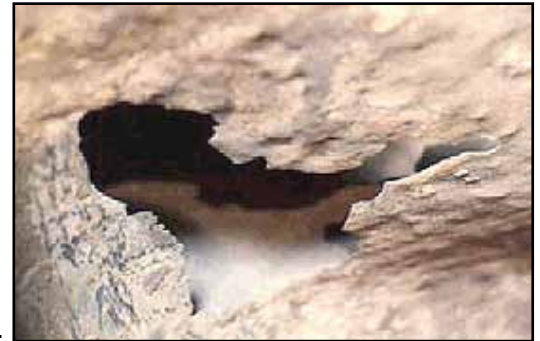
Extreme graphitization had caused holes between the suction and discharge sides of this fan pump after only four years of operation.

1. General view of casing showing graphitization and hole between suction and discharge sides
2. One half of the casing being rebuilt and resurfaced
3. Impeller in position to reform the case rings
