BELZONA REPAIR TO LARGE EXCAVATOR CONTROL CABLE

Ferro-nickel plant in Macedonia

Control cable from large iron ore excavator.

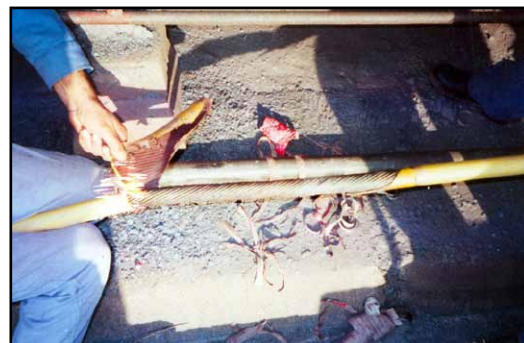
2.

Torn cable cover due to weather influences and friction with ground. There was need for material which is elastic, has good adhesion, abrasion and water resistance.

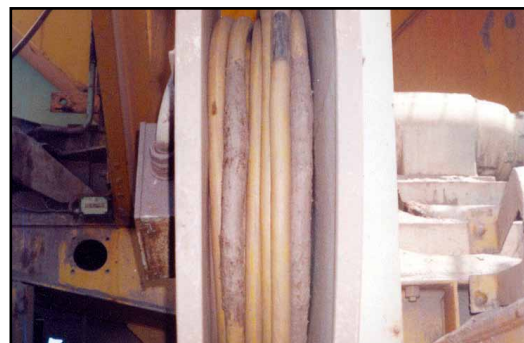
4.

Mechanical bonded rubber coupling had been used before on damaged insulation of the cable, but Belzona® 2311 showed better elasticity, adhesion and abrasion resistance. This application have been done on ten further locations.
