## DEMONSTRATED LONGEVITY IN AN FGD REPAIR

Coal-Fired Power Plant - Cumberland City, Tennessee USA

Flue gas desulfurization scrubber operating at 200°F (93°C) comprised of five spray levels each with six lime slurry pipes.

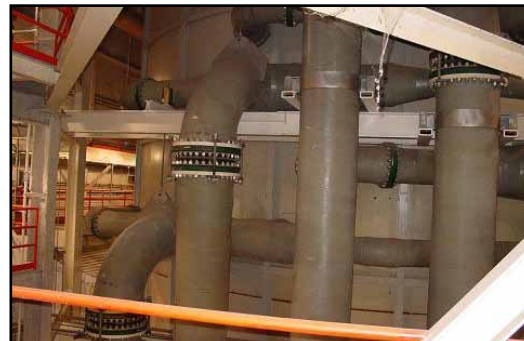
1. Exterior of the FGD at the spray level
2. Severely damaged FRP pipe caused by lime slurry
3. Completed Belzona application to one of six lime slurry header pipes
4. Belzona repair after seventeen months in service

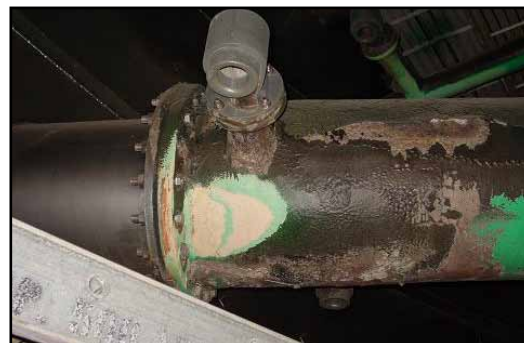
2.

Lime slurry from the four spray levels above had caused an existing polyurea coating to fail exposing the relatively soft FRP piping to the erosive forces of the lime slurry. Should the piping become holed, side streams would decrease the overall scrubbing efficiency resulting in increased operating costs.
