TURNTABLE TROUBLE SORTED WITH BELZONA

Heavy Equipment Repair Shop

Worn Spline and Gear Drive

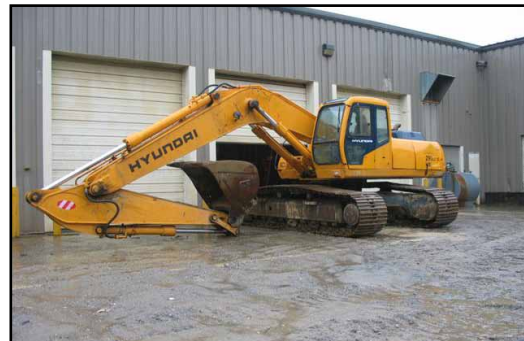
Spline drive and gears were so old and worn that the main deck turntable on the excavator could not operate.

1. Excavator unable to rotate
2. Worn gear
3. Worn drive
4. Worn gear and drive
