HOLED HYDRO TURBINE RUNNER REPAIRED WITH BELZONA

Hydroelectric plant, Vermont

January 2007

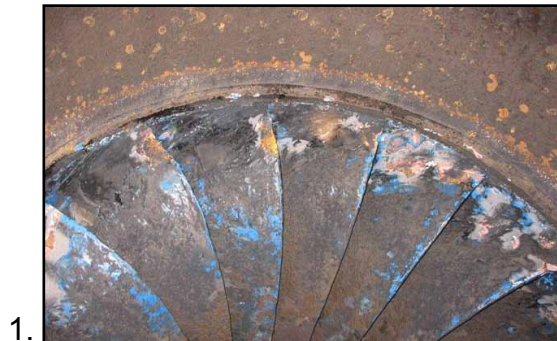
Entrained solids and cavitation caused severe damage to the edges of the runner. Holes and pitting are evident on the runner vanes.

1. Damaged runner with holes
2. Damaged runner with holes
3. Grit blasted clean and ready for coating
4. Finished runner
