CAVITATION DAMAGE IN PUMP REPAIRED

Power Plant / NE Oklahoma

March 2007

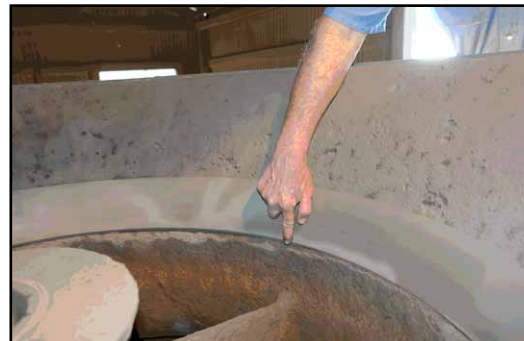
Severe cavitation erosion above and below wear ring. limited time to restore pump.

1. Extent of cavitation damage to suction bell, above and below wear ring
2. Repairing damage back to original dimensions
3. Repaired surface rebated, taped and half coated with Belzona® 2141
4. Finished job ready for bushing installation then into service
