GALVANIC CORROSION IN WATER MAKER REPAIRED WITH BELZONA

FPSO UK, North Sea

July 2002

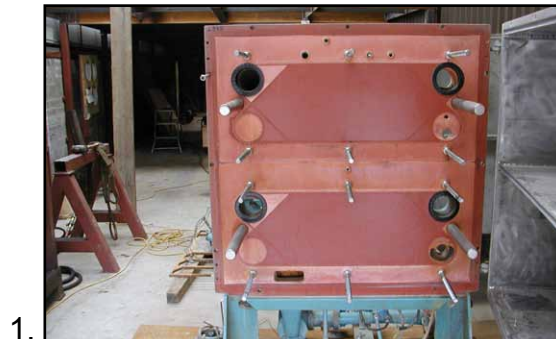
1. Water Maker
2. One of the areas of galvanic corrosion
3. Forming the repair
4. Repair completed, perfectly formed flange face

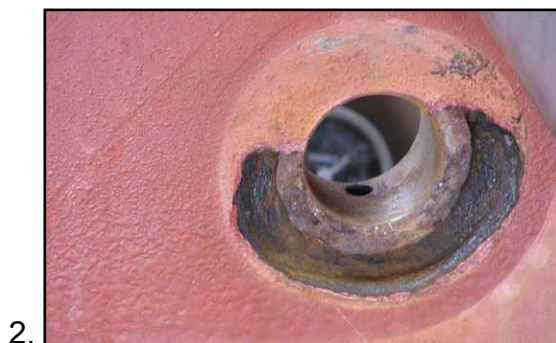
Galvanic corrosion caused by the failure of the insulating gasket caused severe corrosion and under cut the existing glass flake coating. Base material was Carbon Steel plates were Titanium.
