BELZONA REPAIRS CRACKED ENGINE BLOCK

Priest River, ID, USA

1992

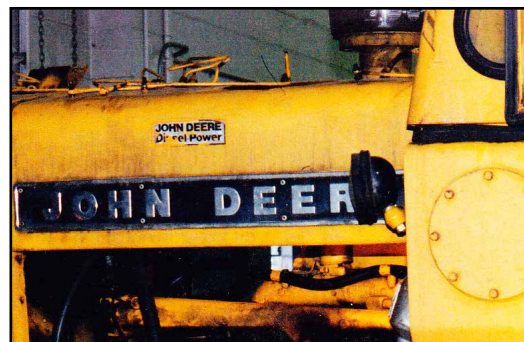
Cracked casing leaks antifreeze.

An early freeze allowed ice to crack the engine casing.

1. JD 444 loader with cracked engine block
2. Crack along the length of the engine block
3. Surface preparation by grinding and inserting studs
4. Completed application; Belzona 1111 seals the crack
