BELZONA REPAIRS ROOF LEAK

Metal roof flashing.

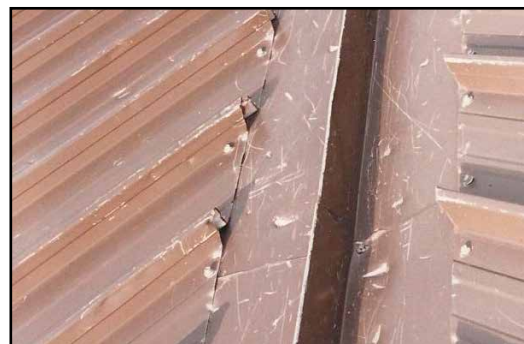
Continual ice build up in the valley forced water under the roof panels due to poor roof design, causing leaks. Someone decided to remove the ice with an ax, causing holes and more leaks.

1. Valley flashing showing ax holes
2. Brushing on Belzona 3921
3. First coat of Belzona 3111 with reinforcing sheet
4. Completed application

Replacing the flashing would have required the removal of most of the roof panels, a considerable expense. The customer was very satisfied with Belzona's solution.
