BELZONA SEALS OIL LEAK FROM TRANSFORMER CABLE GLAND

International Power Company, UK

33kV/11kV Transformer Cable Gland

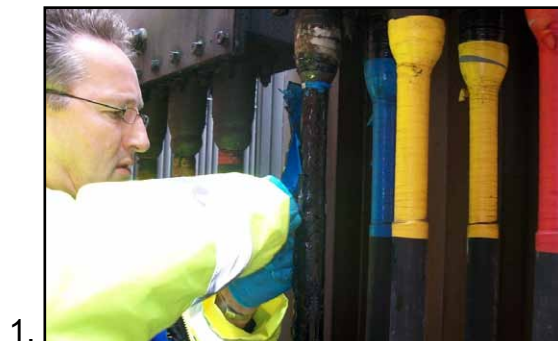
Due to movement and vibration from the transformer, the lead seal to the cable gland on the blue phase of the 11kV distribution cable had cracked. The cables are oil cooled and oil was leaking through the gland. This had been leaking for many years but due to increased pressure from the Environment Agency on electricity distribution companies to reduce the amount of oil leaked to ground, the Company approached Belzona for assistance.

1. Leaking cable gland, previous attempts to stop leak had failed.
2. Substrate cleaned and prepared making the cracked gland clearly visible.
3. Leak stopped using Belzona 1291 and Tourniquet
4. Gland wrapped using Belzona 1161.
