BELZONA PROVIDES COST EFFECTIVE SOLUTION TO CONVEYOR BELT REPAIRS

Waste Management Company, Manchester UK

August 2010

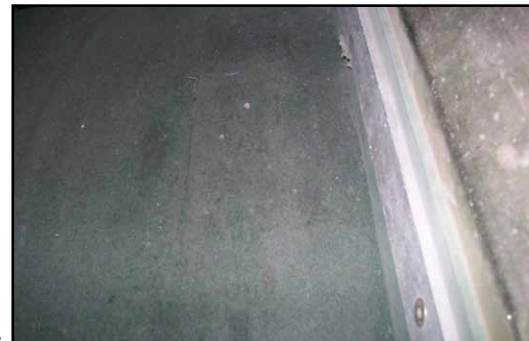
1.

An L shaped cut approximately 300mm across the length of the belt was found in a new conveyor belt.

PICTURES
