## PROPELLER CAVITATION DAMAGE REPAIRED WITH BELZONA

Ship Dockyard, Bulgaria

Bronze propeller of bulk carrier.

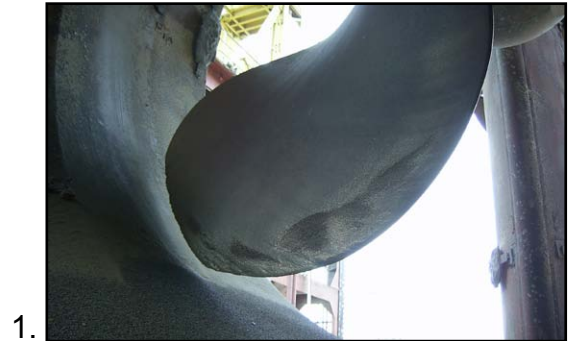
The cavitation damage close to the edges of the bronze propeller caused lower hydrodynamic efficiency and propulsion capabilities of the vessel.

1. The general view of cavitation damages after grit blasting
2. After rebuild with Belzona® 1311 two coats of Belzona® 1321 were applied
3. Inspection one year after the repair found some small mostly mechanical damage that were prepared by Bristle blasting
4. The damaged areas were corrected with Belzona® 1321
