STEEL PLANT BACK ON LINE WITH BELZONA® WRAP

Steel Plant, Teesside, UK

Leaking 24 inch cast iron coke oven gas main from the coke ovens to the power plant.

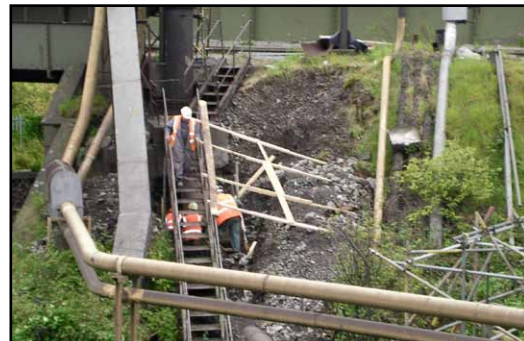
1. Site access to excavated pipe section
2. Excavated 24 inch Gas Main with crack identified
3. Completed Belzona® 1121 wrap

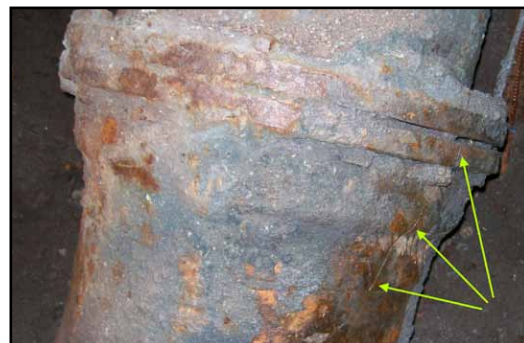
The gas leak on the cast iron pipe was detected and once excavated a 10 inch long crack over the socket area was found to be the cause. The pipe was critical to the plant operation so an immediate solution was required. The coke oven gas had a typical internal pressure of 500 mbar and client needed to reduce the repair period to a minimum.

The crack was terminated and vee'd cut in accordance with Belzona Know-How System Leaflet VPF-8. Belzona® 1121 was used to pack the gasket and create fillets on either side of the flange, before conducting a wrap repair in accordance with Belzona Know-How System Leaflet VPF-11a.
