BELZONA TRANSFORMER LEAK REPAIRS ON TERTIARY BOX

Electricity Substation, UK

Exterior/Rooftop of Super Grid Transformer Tertiary Box

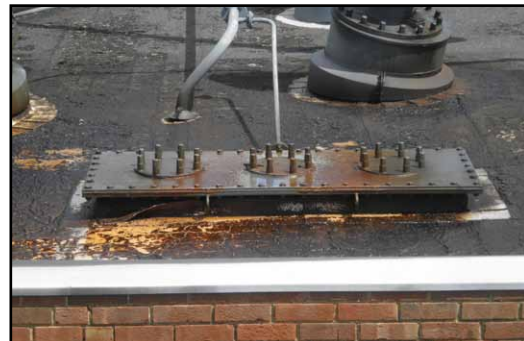
The transformer had been suffering from extremely high losses of transformer oil. Following a site survey, oil discharges were evident at many of the flange and bolt joints to equipment located to both the interior and exterior of the noise enclosure. The root cause of the oil leaks was found to be the tertiary box located in the noise enclosure on the rooftop.

1. Tertiary Box during survey
2. Completed application
3. Completed application

The application was carried out in accordance with modified versions of Belzona Know-How System Leaflets VPF-8 & 11. The tertiary box substrate was prepared before Belzona 1221 was used to stem any active oil leaks. The flange joint was sealed using Belzona 1161 incorporating Belzona 9341 (Reinforcing Tape). Bolt and nut heads, together with male studs were protected by either bridging tape or tight fit former, then fully encapsulated using a disposable former containing Belzona 1161. Following the curing process, the formers were removed and all of the repair areas were coated with Belzona 5831.

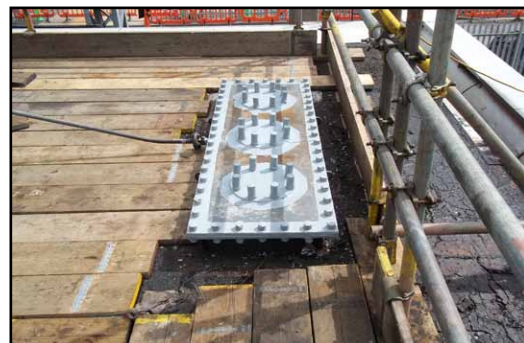
The leak sealing project was successful. In recharging the transformer with oil to the correct level, neither the flange or bolt heads showed any visual evidence of further leakage. The clients request that the studs be protected prior to encapsulation of the bolt heads was also met.
