SERVICE LIFE OF DREDGING FLUSH WATER PUMP EXTENDED WITH BELZONA

Dry dock, Bremen, Germany

Rubber-lined KSB flush water pump on North Sea dredger.

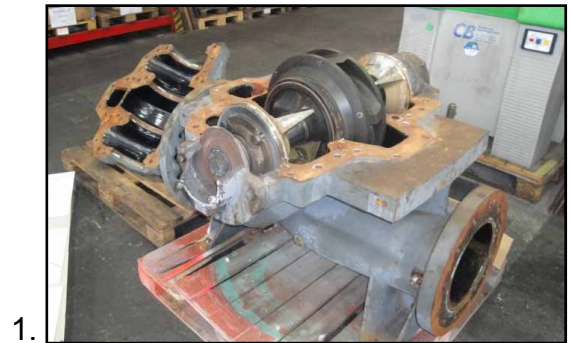
Extensive cavitation damage near impeller and high pressure areas. Cavitation and erosion had led to the pump casing's rubber lining being partly eroded. Further erosion damage was found on the casing.

1. Damaged rubber-lined pump
2. Close-up of one of the damaged areas
3. Damage rebuilt with Belzona® 1812
4. Completed application with Belzona® 2141 applied
