BELZONA REPAIRS BROKEN HYDRO ELECTRIC TURBINE RUNNER

Hydro Electric Plant, USA

May, 2007

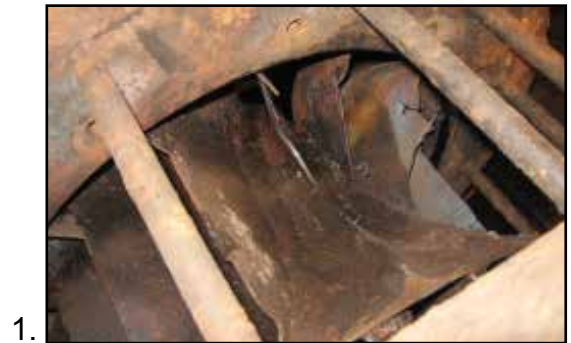
Wicket gate came loose and fell into turbine breaking three blades on runner.

1. Broken runner blade
2. Expanded metal tack welded
3. Blades rebuilt with Belzona® 1311
4. Completed application after coating runner
