RUBBER TRACKS ON MOBILE DRILLING RIG QUICKLY REPAIRED WITH BELZONA

Geotechnical survey company, Croatia

September, 2013.

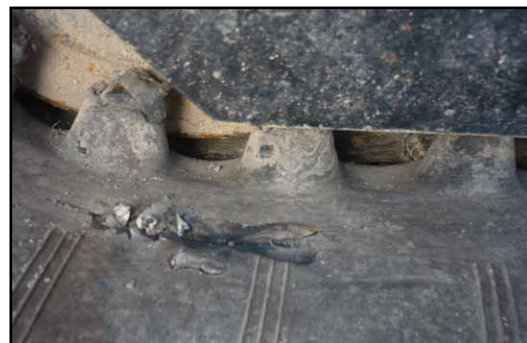
2.

Several damaged areas on its rubberized tracks required quick repair to prevent track failure.
