BELZONA IS THE KEY TO A SOLID KEYWAY

Kettle Falls, WA, USA

May 2014

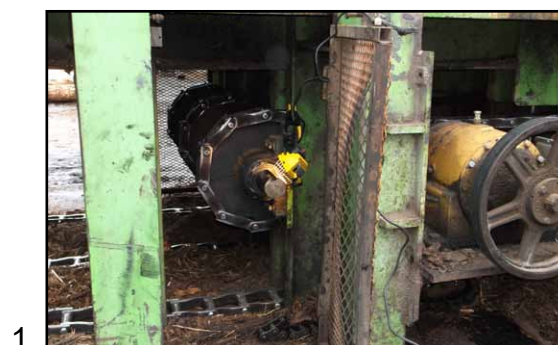
1. Warming up the shaft
2. Damaged shaft
3. Ready for reassembly
4. Completed application

The application was carried out in accordance with a modified version of Belzona Know-How System Leaflet MPT-4. The application was completed in May so the temperatures were a little cool. The area was warmed up using a halogen lamp. A grinder was used to remove the mushroomed area on the shaft and to clean up and cut back the rest of the keyway so a solid amount of Belzona 1221 could be introduced to the damaged area. Belzona 9411 was applied in two layers to the new key and the inside and shoulders of the two-part gear. The Belzona 1221 was then mixed according to the Instructions for Use. The first layer was scrubbed in using a short bristle brush to embed material into the roughened surface. Then the remaining amount of Belzona 1221 was applied carefully to avoid any air pockets. The new key was then pressed in and the excess Belzona 1221 scraped off. The new two-part gear was then set into place and tightened down.

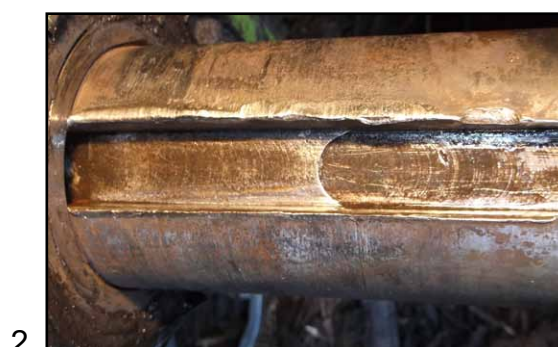
Keyway was damaged and loose.

This plywood mill had a problem with a damaged keyway on the shaft that runs the log entry system to the plant. They had already been forced to replace the large gear for \$3000 USD because the loose key had damaged it. The new gear was starting to show signs of damage as well. Failure of the keyway on this shaft would result in a total plant outage.

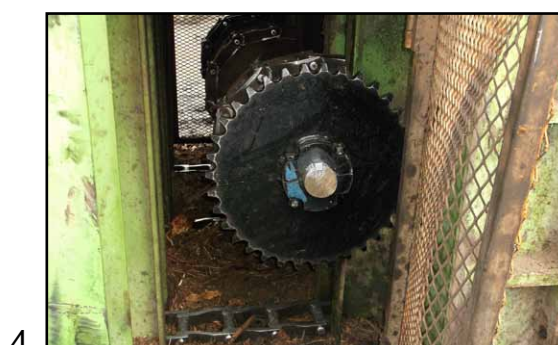
With the potential of a plant shutdown, being able to repair this keyway in-situ was priceless to this mill. Already having had to spend \$3000 USD for a new gear, and being faced with spending another \$3000 USD to replace it again after only 2 weeks, Belzona was a perfect example of saving time and money with a cost of less than \$100 USD to complete this application. Belzona 1221 was chosen for this application based on a 6-hour window to complete the repair. Well over 1 year later the keyway continues to be run everyday with no sign of wear. The customer is very happy with this repair.
