FLANGE REPAIR KEEPS PUMP GOING

Cracked flange on cooling water pump.

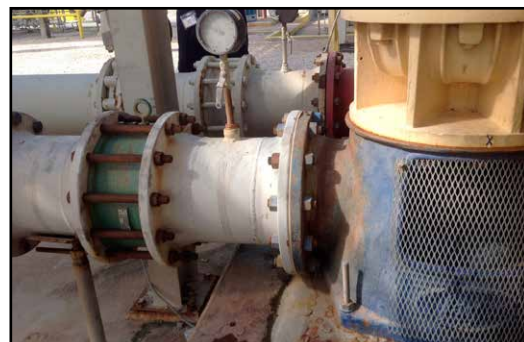
1. Overview of the pump and flange before the repair
2. Belzona 1121 used to build up the area and the composite wrap applied
3. Completed project
