BELZONA REPAIRS PROFILE OF HYDROELECTRIC DAM

Rebuilding the profile of a small hydroelectric dam.

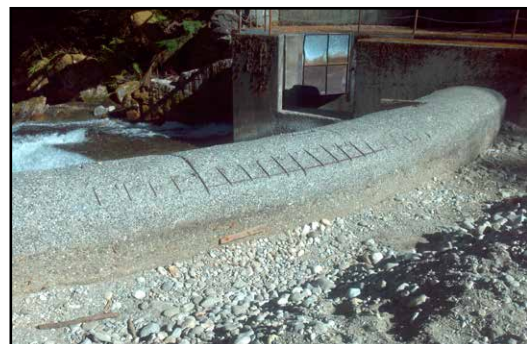
The profile of a small hydroelectric dam became worn, exposing reinforcing bar, which was caused by damage from VW Beetle sized boulders tumbling into and over the face of dam during spring runoff. The client was concerned about maintaining the integrity of the small hydroelectric dam and restoring the original profile.

1. Dam (ogee) profile before repairs
2. Several pallets of Belzona 4111 on site
3. Dam repairs underway - note templates & mixer
4. Completed application
