BELZONA FIXES A CRACKED CUTWATER ON A FAN PUMP

Cracked casting seam on a fan pump at a paper mill.

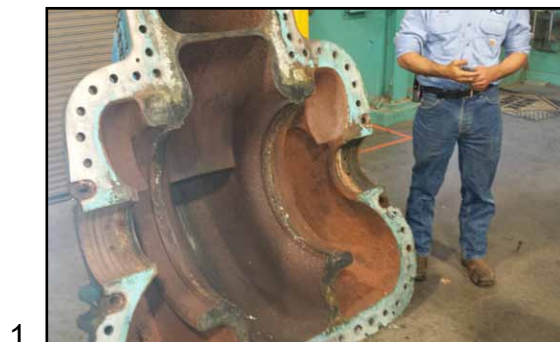
Casting seam on the cut water of this Gould pump had separated and was beginning to erode from being in use.
