BELZONA SAVES THE BULL GEAR

Ore processing Ball Mill bull gear.

The gears on this Ball Mill bull gear were experiencing erosion and pitting.

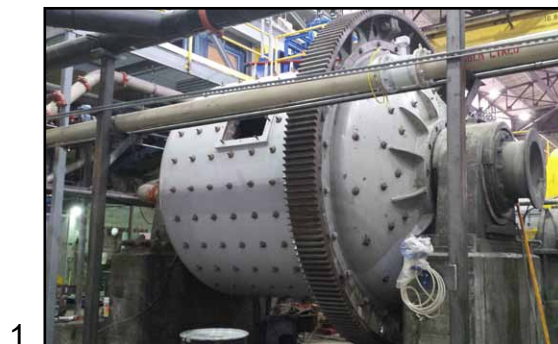
1. 1 of 5 Ball Mills.
2. Erosion damage cleaned and grit blasted.
3. Application of Belzona 1111.
4. Application of Belzona 1321.
