BELZONA SEALS BROKEN SKYLIGHTS

Office building, Bielsko-Biala, Poland

July 2009

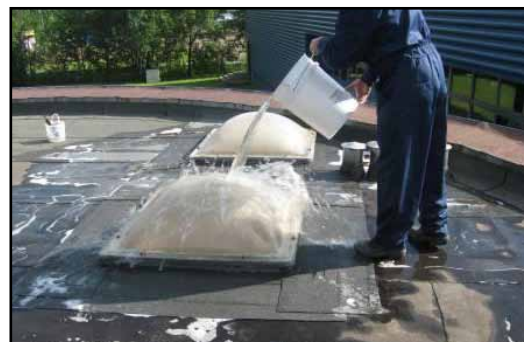
Due to sun exposure the seals had broken around the fastening bolts causing water leakage into the building each time it rained.

1. Washing damaged skylights
2. Application of Belzona 3111 onto the Belzona 3911 Conditioner
3. Rooftop view immediately after the repair.
4. Rooftop view August 2016

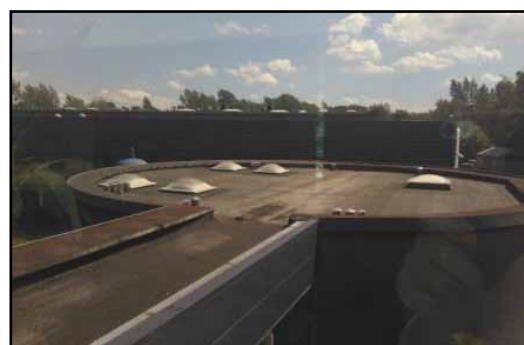
4.

Repair cost less than half the purchase and replacement costs of new skylights. Inspected in August 2016 repairs still in excellent condition and keeping offices dry.
