CENTRIFUGAL PUMP REPAIRED AT A FRACTION OF THE COST OF REPLACEMENT

Pump handling pulp.

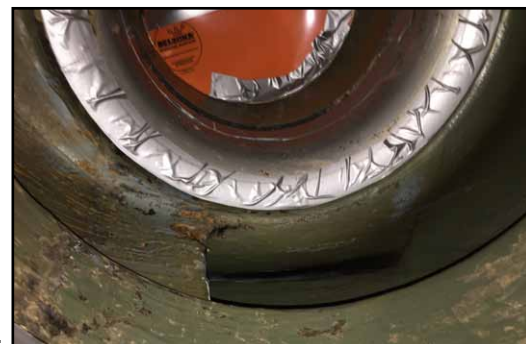
Badly damaged pump casing internals with pitting could not be removed and replaced or put back in service.

1. Corroded and damaged pump before application.
2. Pump casing coated with Belzona 1331.
3. Pump casing seven months after the application. This time instead of coating or replacing, the plant inspected and returned to service with little to no down time.
