BELZONA SUPERWRAP II REPAIRS 6" OPEN DRAIN SYSTEM

Oil Field Operator, North Sea, Norway

October 2016

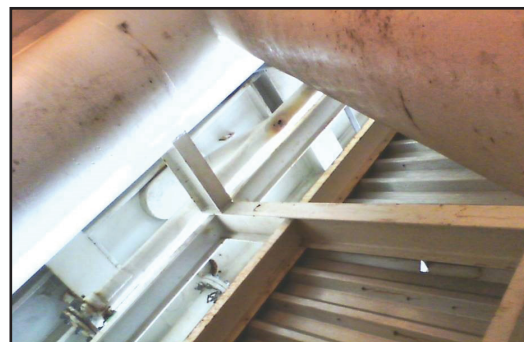
Internal corrosion caused multiple through-wall defects on the pipes.

1. The defective pipe
2. Pipe system following surface preparation
3. Completed application detail
4. Completed application
