BELZONA REPAIRS LEAKING CPVC COOLING WATER LINES

Cooling water line for biomass power generation turbine.

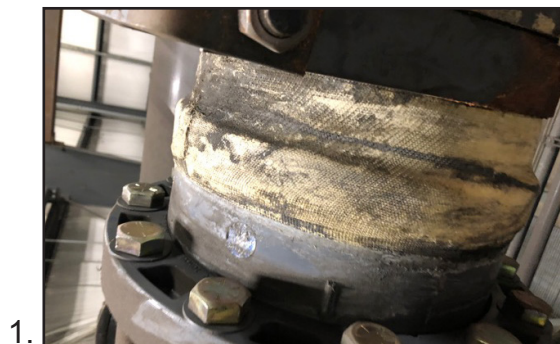
The customer was experiencing significant water leaks from a 250mm (10 inch) cooling water line, through an existing non-Belzona wrap repair. The leaks were occurring at the fitted flanges of two separate lines. Due to the severity of the leak, the biomass generation turbine was taken out of service until a Belzona repair could be completed.

1. Water leaking through existing wrap repair.
2. Cleaning CPVC with Belzona 9111.
3. Completed Belzona 1161 repair.
4. Completed Belzona 1161 repair to a parallel line.
