BELZONA SEALS LEAKING WATER TANK

Automotive factory, Slovakia,

Insulated water tank

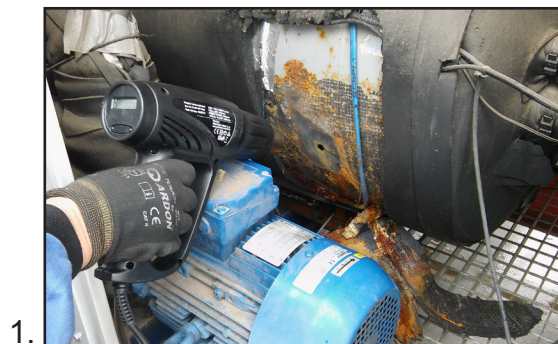
Corrosion under insulation caused by contamination from chemically treated water led to 9.5mm hole in the tank.

1. Preparing for application
2. Belzona 1111 on the steel plug
3. Plug application in the hole
4. Completed repair with Belzona 1111 incorporating Belzona 9341 applied
