BELZONA REPAIRED DAMAGED MIXER AGITATOR DRIVESHAFT AND KEYWAYS

Mixer agitator driveshaft and keyways

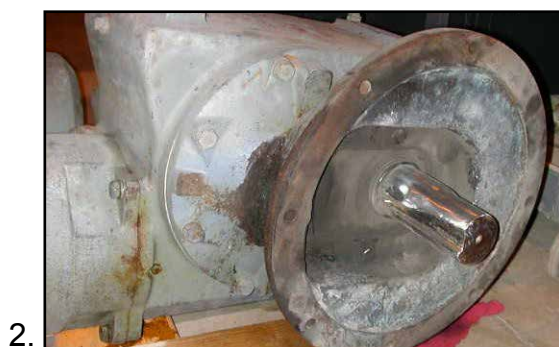
Acid damaged shaft lost 1/2" on the diameter, keyway and key were destroyed. Socket keyway was minimally damaged, but needed to be tightened up. Obsolete drive was built in 1965 and the MFG has been sold twice. Therefore, no parts or prints are available. Mixer shut down. It was imperative that it would be operated in only two days.

The application was carried accordance to the modified version of Belzona Know-How leaflet system MPT-2. Belzona 1111 was used to build up the shaft diameter and also applied inside the socket and around the new key to fill the keyways. While still wet, the shaft was carefully dropped into the agitator socket keeping the key tight in both keyways.
