BELZONA SEALS TRANSFORMER LID FLANGE

Gas Distributor, UK

2011

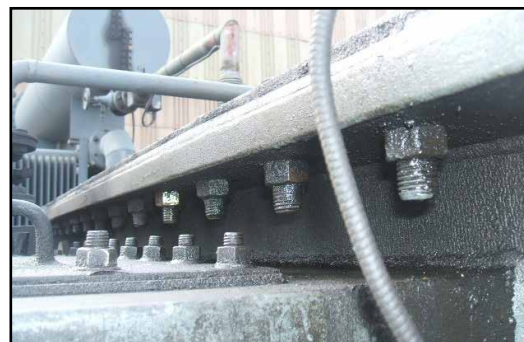
Most of the gasket had failed around the 10m perimeter of the lid, with oil seeping down the sides and going to ground. Unfortunately it was not possible to drain the oil below the gasket level and so the application had to be pursued as a live leak with a 1 meter head pressure.

1. Original condition of flange, with header tank at rear
2. Encapsulation of bolts with Belzona 1161
3. Completed repair close up
4. Finished work after 3 days

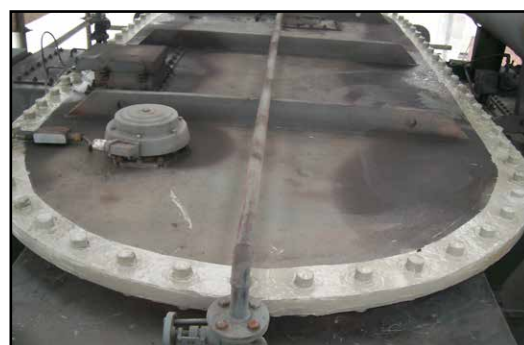
4.

The customer was desperate for a fast solution to the problem and whilst there were a couple of very minor leaks still on completion, these were deemed to be well within acceptable limits. The customer was delighted with the results and is looking to repeat the application to other transformers on their site.
