BELZONA REPAIRS TRANSFORMER FLANGE OIL LEAK

Flanged pipe connections on transformer flange at the major power company.

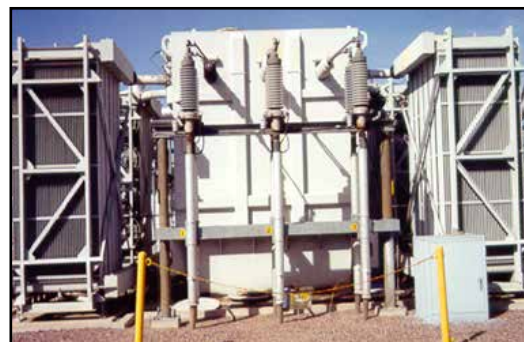
Oil leaks raised maintenance, EPA and safety concerns. Replacement of gaskets would require shut-down and dismantling of equipment.

1. Oil leak area of transformer
2. Seal with Belzona 1221, then pour Belzona 2221 encapsulated the flange
3. Application completed
