CRACK REPAIR OF A GAS ENGINE POWER GENERATOR WITH BELZONA

CUSTOMER
Hungary

APPLICATION DATE
2021

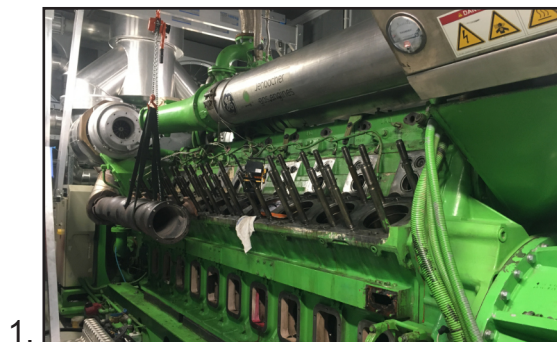
1. A total shot of the engine.
2. Surface preparation through the small hole
3. Application is in process
4. Repaired crack

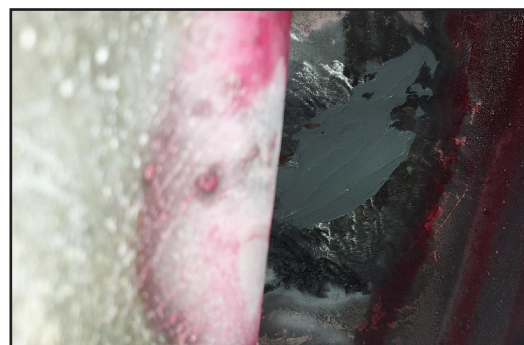
4.

The operator noticed a significant loss of the cooling liquid. After a thorough investigation a crack in the cooling liquid chamber was found.

The crack was found deep inside the GE Jenbacher gas engine. The area to be repaired was difficult to access and the regular surface preparation (SA2,5 and 75 microns) was not an option.

Belzona 1212 was chosen to repair the crack. As easy application was expected due to its perfect surface tolerant properties.
