## SF6 GAS LEAK REPAIR

Wind farm, Australia

May-21

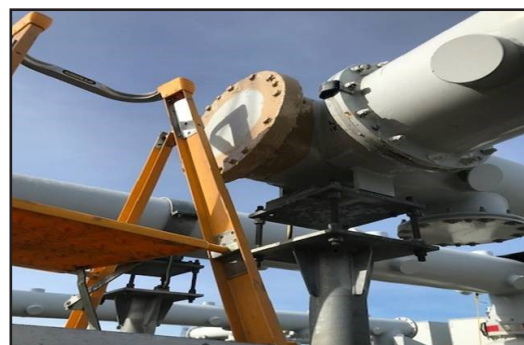
2.

SF6 gas leaks were observed on flanges and needed to be sealed to prevent further leakage of this extremely potent greenhouse gas.

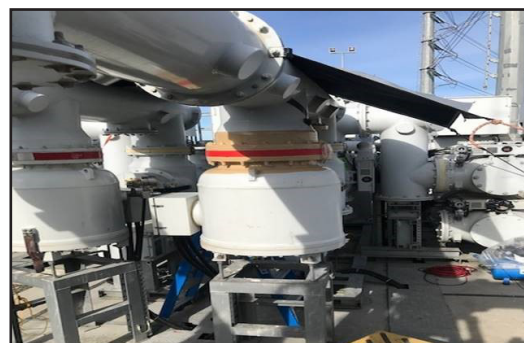
4.

8 Flanges were successfully repaired, the client was happy and additional repairs will be carried out soon.

Surface was prepared with power tools, such as bristles blasters and grinders to achieve a good profile for the Belzona to adhere. Belzona 1161 and reinforcing tape was applied around the outside of the flange. Then all nuts and bolts were coated with Belzona 1161. Belzona 5831 was then applied over the Belzona 1161 repair area to ensure a good seal and dress up the application
