BELZONA REPAIR TO CRACKED GLAND SEAL IN FOSSIL PLANT

Fossil Plant in Maryland

Gland seal in feed pump

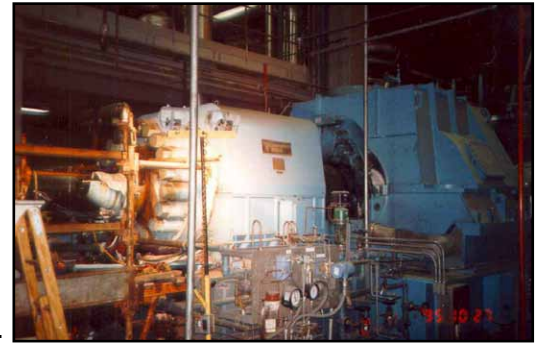
Gland seal had a cracked casing. The condensate used in the gland seal system was leaking and causing a safety problem.

1. Main Feed Pump - note rust around the gland
2. Casting on work bench prior to surface prep
3. Application of Belzona® 1111
