BELZONA PUMP REPAIR PROVIDES OVER TEN YEARS OF UNINTERRUPTED SERVICE

Paper Company in Georgia

Primary fan pump

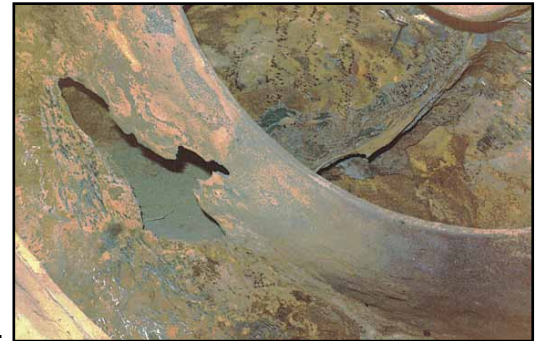
Pump suffered from erosion/corrosion and was completely destroyed after four years of operation

1. Severe damage
2. The wear ring seats rebuilt, clamps help ensure proper alignment
3. Belzona® 1321 (Ceramic S Metal) coating
