I.D. FAN SHAFT REPAIRED IN SITU WITH BELZONA

Power plant, Bulgaria

May 2006

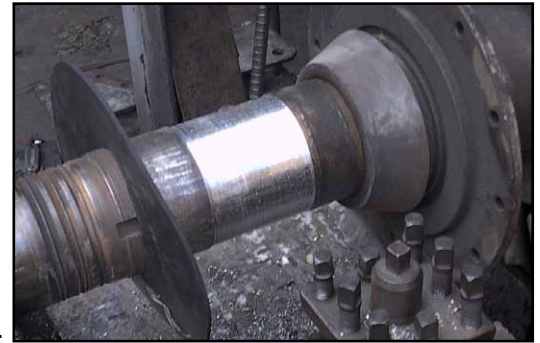
Shaft damaged at bearing location by seized bearing.

1. Damaged area of the shaft undercut
2. All machining and application work carried out on site by using fan rotation and small hand lathe
3. Belzona® 1111 applied
4. Machining to the final diameter
