BELZONA REPAIR TO INTERNAL ROOF DRAIN STILL OK 24 YEARS LATER

Auto manufacturer, Wentzville, MO

Internal downpipe, part of roof drainage system.

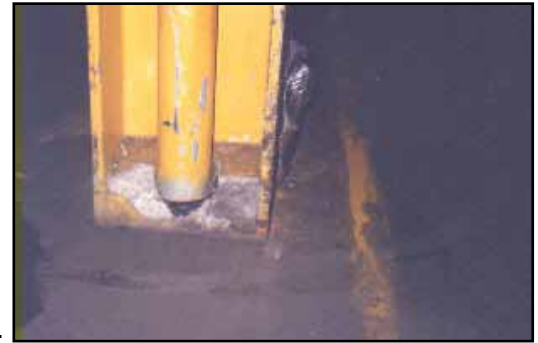
Hit by a fork lift truck, the pipe broke off at the floor level and leaked water everytime it rained.

1. Broken pipe, summer 1984
2. Repair completed
3. Revisited February 2008 and still performing

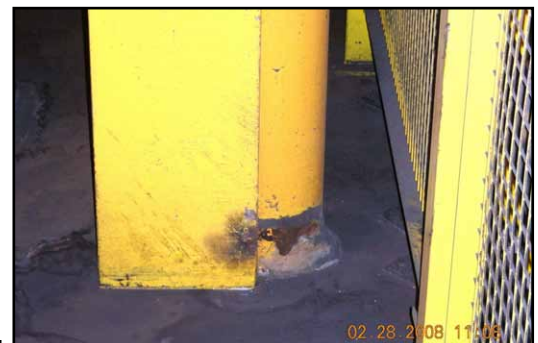
To change the broken pipe would involve a pipefitting/labor crew at least a week to excavate down below the floor three feet. Belzona application took just 20 minutes to complete. 8 man crew, 40 hours labor at \$50.00/hr = \$16,000 saved. Revisited February 2008, still performing.
