## CAVITATION DAMAGED IMPELLER REPAIRED WITH BELZONA

Water Treatment Plant, Virginia.

Vertical water distribution pump.

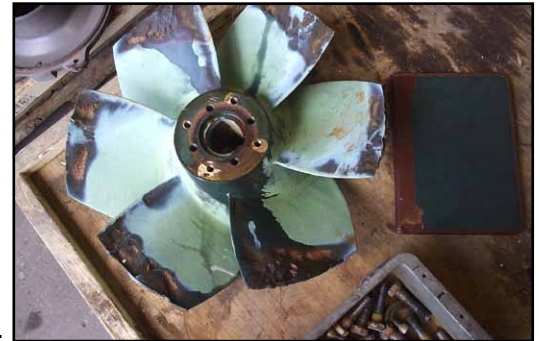
Impeller was damaged by cavitation leading to vibration in the pump. NSF approved products required.

1. Impeller showing Cavitation Damage
2. Impeller repaired with Belzona® 1221
3. Impeller coated with Belzona® 1341N
4. Impeller installed into pump and ready for service
