BELZONA REPAIRS ENGINE BLOCK

Seward, AK, USA

Engine block.

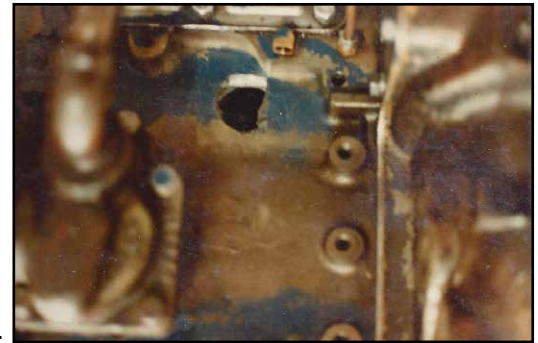
A hole in the engine block allowed the oil to leak out.

A broken connecting rod went through the block. The owner replaced the rod but did not know what to do about the hole. Belzona repaired the hole, solving the problem for the owner.

1. The engine block showing the hole
2. The cracks have been stabilized by drilling the extremities
3. A plate was bonded over the hole using Belzona 1111
