BELZONA REPAIRS CRACK ON ENGINE BLOCK

CUSTOMER
Idaho, USA

APPLICATION DATE
1992

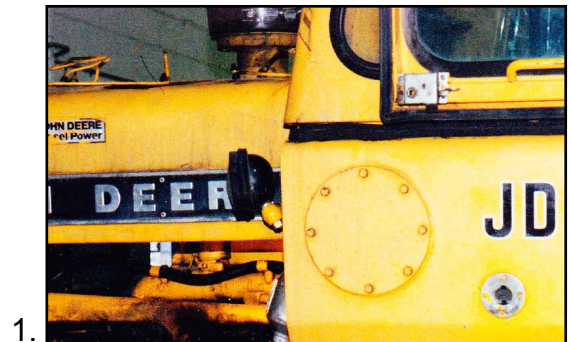
PROBLEM
An early freeze allowed ice to crack the engine casing.

1. JD 444 Loader with cracked engine block
2. Engine showing long crack in water jacket
3. Area prepared with studs in place
4. Completed application

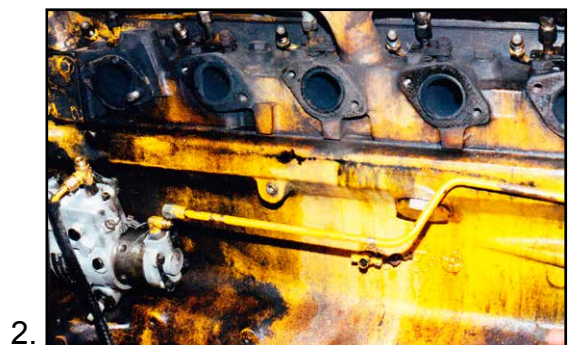
APPLICATION SITUATION
Cracked engine casing leaks antifreeze.
