BELZONA REPAIRS DISCHARGE PIPES OF A CYCLONE FEED SUMP

CUSTOMER
Mine, Bolivia

APPLICATION DATE
February 21, 2011

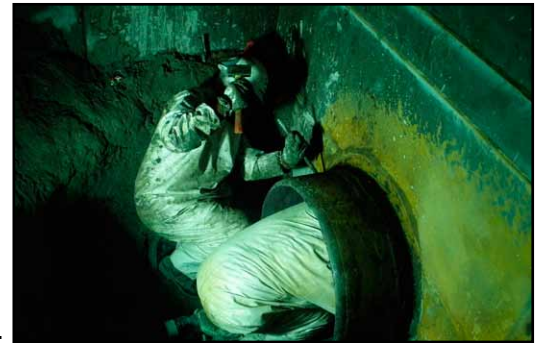
APPLICATION SITUATION
The discharge pipes of the cyclone feed sump were loosened from the Concrete Wall due to impact and wear in the metallic structure caused by abrasion.

PROBLEM
Damage of concrete. Loosening of the discharge pipes of the cyclone feed sump, caused by impact. Wear in the interior of the ducts, due to ore abrasion.

1. Preparation of the surface
2. Injection of the Belzona 4151 to fill the space between the wall and the pipe
3. Repair of damaged concrete with Belzona 4111
4. Belzona 1812 coating to protect against wear caused by abrasion.
