## BELZONA RESTORES DAMAGED CLUTCH ON DREDGER

Gravel pit, Croatia

April 2013

Dredger pumping gravel and water from the bottom of the lake

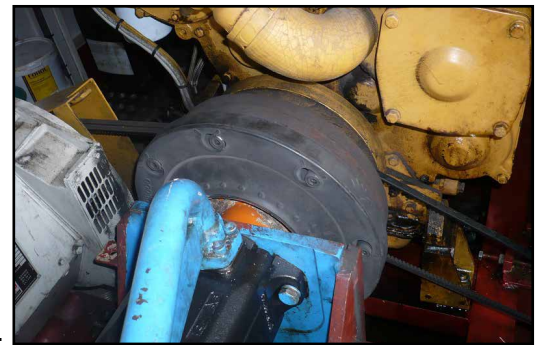
1.

Rubberized clutch suffered damage during operation of the engine. The holes became deformed and the clutch was no longer performing as needed.
