BELZONA REPAIRS DRIVE SHAFT ON ROLLING MILL

Steel Plant, Leningrad Region, Russia

Deteriorated drive shaft on four high rolling mill.

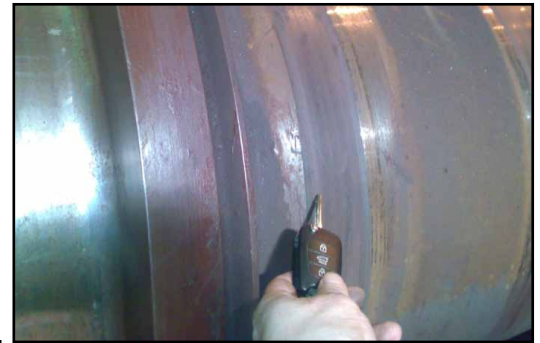
Deteriorated shaft in gasket seating areas (6 gaskets 50-90 m wide with a diameter of 709.25 mm on each shaft) causing excessive oil consumption. Original Belzona application lasted 12 years so the customer immediately turned to Belzona again.

1. Close-up view of the damaged shaft area
2. Prepared surface for the application of Belzona 1131
3. Application of Belzona 1131
4. Completed shaft repair
