BELZONA REPAIRS DAMAGED TURBINE FLANGE FACE

Chemical plant, Slovakia

Split casing of steam turbine.

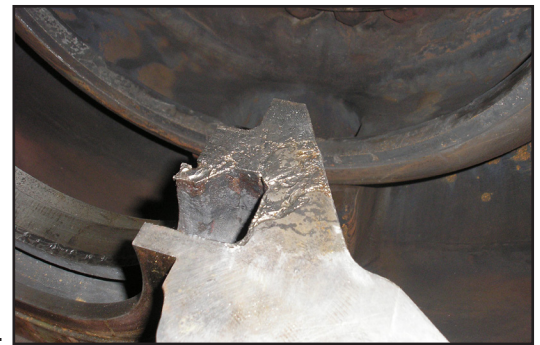
Wet steam caused erosion corrosion damage to flange face of turbine casing. This damage meant steam leakage from the turbine.

1. Damaged turbine split casing
2. Glass panel (coated with Belzona 9411 Release agent) used to form flat surface on Belzona
3. Repaired area
4. Turbine ready for mounting
