BELZONA REPAIRS LEAKING TANK ROOF

Sealing holes on the roof of an oil tank.

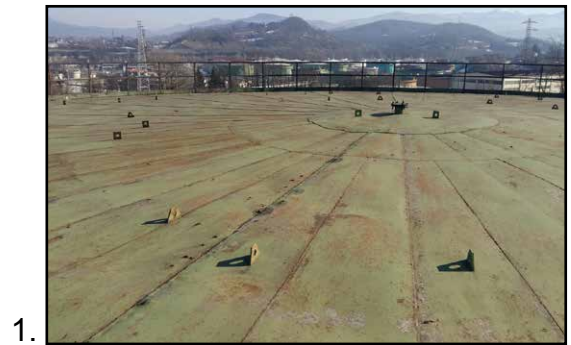
1. Overview of the tank roof
2. Water ingress at the weld seams
3. Belzona 1161 being applied
4. Finished application with Belzona 3111

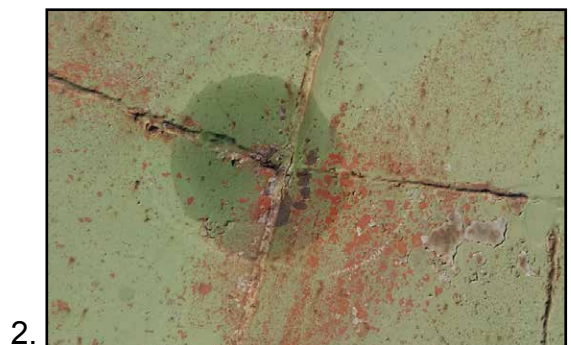
A tank roof has failed and started corroding at the weld seams. This was allowing water to seep in through these holes causing contamination problems for the solution within the tank.

Previous welding had introduced heat activated zones into the tank roof resulting in weakness and corrosion at the weld seams. Welding the tank again would have created the same problems and that's why the Belzona cold applied solution was used.
