STEEL PLANT BACK ON LINE WITH BELZONA WRAP

Steel Plant, Teesside, UK

Leaking cast iron coke oven gas pipe.

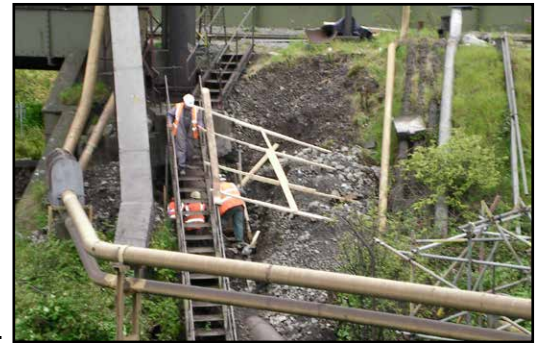
1. Site access to excavated pipe section
2. Excavated 24 inch Gas Main with crack identified
3. Completed Belzona 1121 wrap

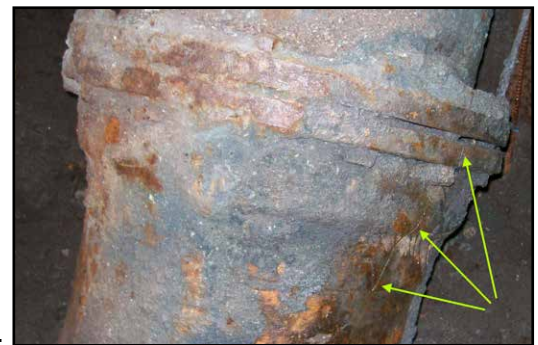
2.

Gas leak on the 24" cast iron pipe was detected and once excavated a crack of 25 cm length over the socket area was found to be the cause. The pipe was the gas main between the coke ovens and the power plant and so an immediate solution was required. The coke oven gas had a typical Internal pressure of 500mBar and client needed to reduce the repair period to a minimum.

The crack was terminated and V cut in accordance with Belzona Know-How System Leaflet VPF-08. Belzona 1121 was used to pack the gasket and create fillets on either side of the flange, before conducting a wrap repair in accordance with Belzona Know-How System Leaflet VPF-11a.
