## MINE LOCOMOTIVE AXLE REPAIR

Brown coal Mine plant, Slovakia

2005

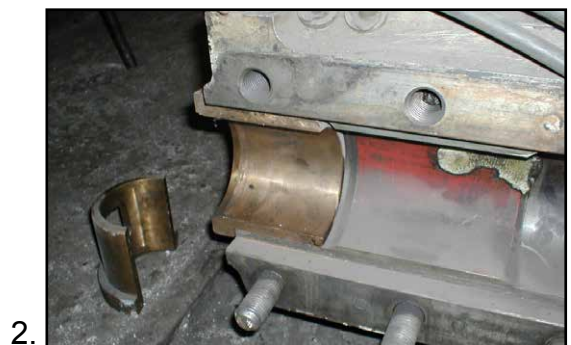
Slide assembly wear of the shaft axle caused by a bronze bearing and causing a high level of noise.

Failure of the shaft
